Birsay Heritage Trust

Buildings at
HMS TERN
Twatt, Birsay

CONDITION REPORT and PROPOSED WORKS

January 2014

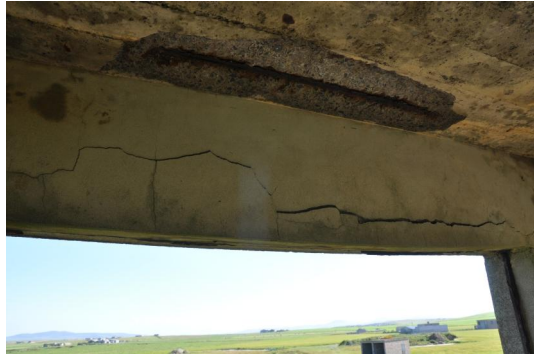
1.1.1 Concrete lintols

Original concrete lintols at tower level are in poor condition.

Allow for removing spalling concrete, descaling and treating exposed reinforcement and patching with proprietary repair material.

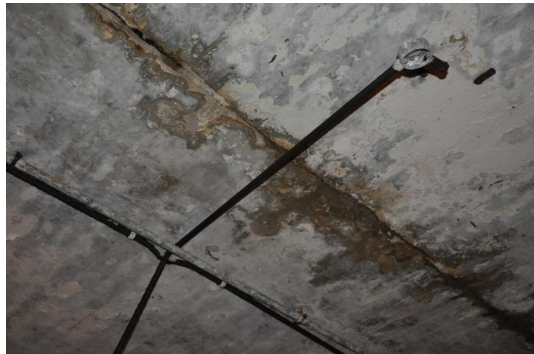
1.1.2 Concrete slabs

Existing roof slabs have various cracks and suffer from localised spalling of concrete cover to reinforcement.

Allow for cutting out cracks to sound base and repointing with proprietary repair compound.

Allow for removing spalling concrete, descaling and treating exposed reinforcement and patching with proprietary repair material.

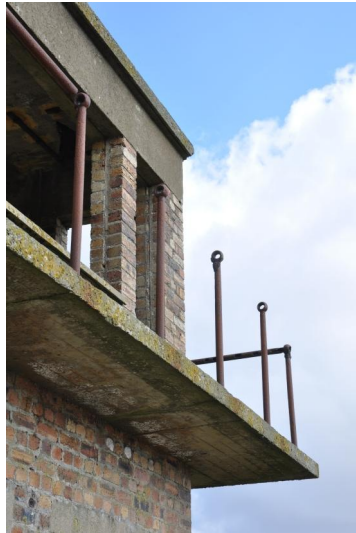
1.1.3 Supports for balcony

Existing balcony is in only fair condition and suffers from cracking (Structural Engineer's Report: 3.4.8)

Allow for cutting out and sealing cracks with epoxy.

Provide new steel support brackets.

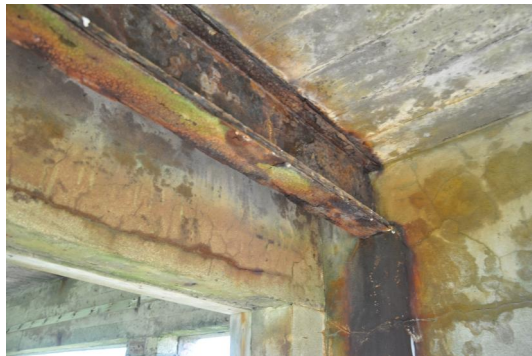
1.1.4 Beam to top level of control tower

Beam is heavily corroded and causing damage to building

Replace beam to tower

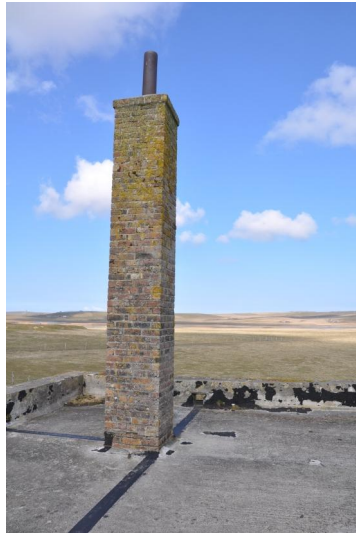
1.1.5 Brick Chimney

Structural Engineer's Report identifies possible issues with slenderness of chimney and proposes bracing of chimney.

Provide steel collar and brace to chimney.

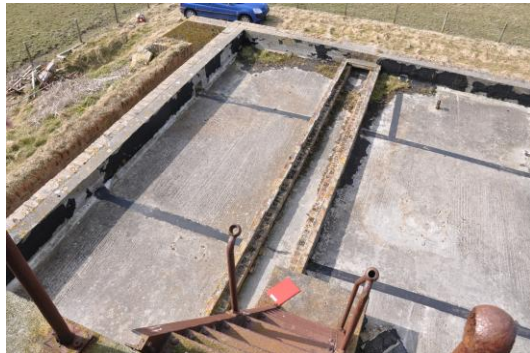
1.2.1 Roofcoverings to main roof

Existing roofcoverings mostly eroded.

Roof was formerly covered with gravel for blast protection but this has been removed.

Overlay with insulation on vapour barrier overlaid with ply deck.
Install new single ply roofcoverings.
Include for forming roofcoverings over roof duct and to parapet with lead flashing to edge.

Omit gravel.

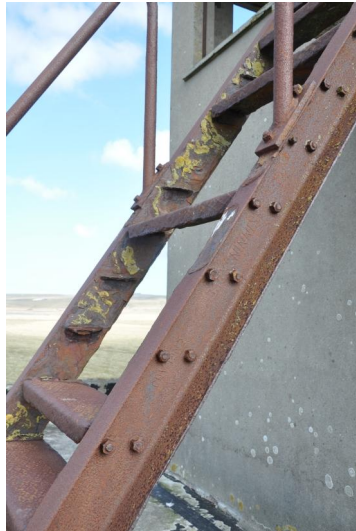
1.3.1 Roof Access and stair

Existing steel stair between roof and tower level is badly corroded and too steep to act as public stair.

Existing stair to be restored/replaced to original pattern.

Form new galvanised steel stair and roof access walkway to allow safe public access as drawings.

Form new galvanised steel steps to first floor level of tower.

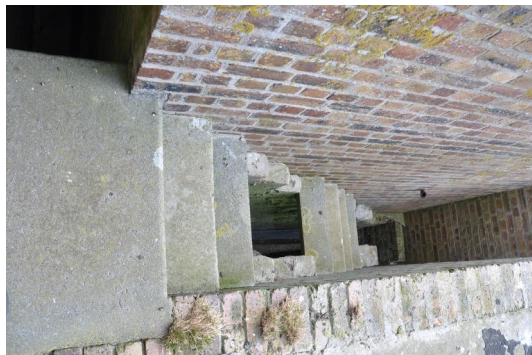
1.3.2 Stair from ground floor to roof

Stair has a number of broken treads and is too narrow to provide adequate access.

Remove stair and make good as required.

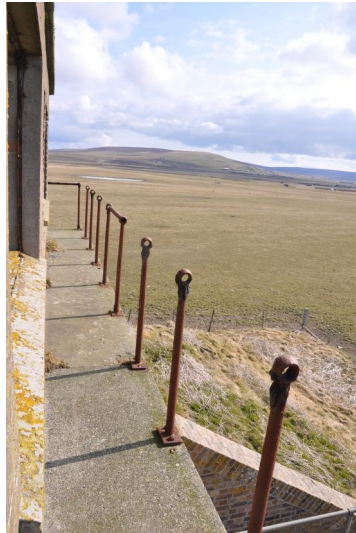
1.3.3 Handrails to balcony

Existing handrail is badly corroded

Allow for cleaning down existing handrail, replacing rail and fitting replacement sections as required. Allow also for mesh infill panels to allow public access

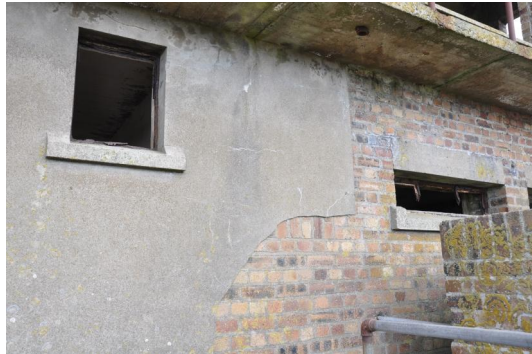
1.4.1 Brick walls

Walls are generally in good condition.

Parts of tower have cement render which is in poor condition and is either boss or has fallen from the walls.

Remove all loose and boss render and re-render tower.

Allow for powerwashing walls to remove algae growth and provisionally for minor repointing.

In particular fill drilled shot-holes to walls of building.

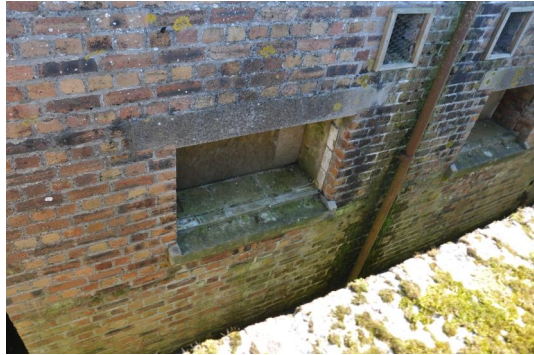
1.5.1 Glass brick windows to ground floor

Former glass brick windows have been broken and removed

Reinstate glass brick windows

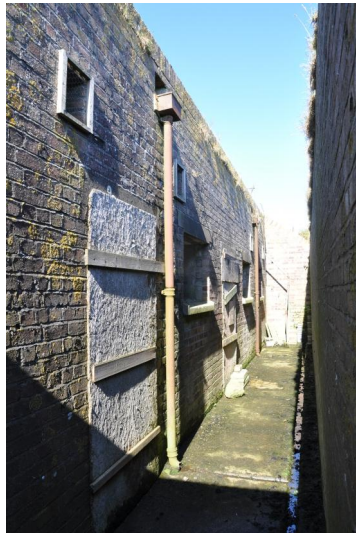
1.5.2 External Doors

Original timber doors have been removed

Reinstate timber framed, ledged and braced doors.

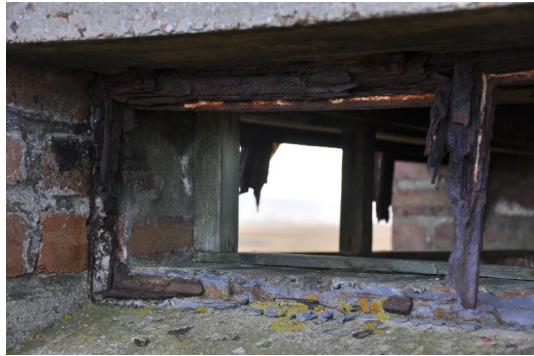
1.5.3 Windows

Original steel windows are largely missing and the few remaining ones are corroded beyond repair.

Replace windows

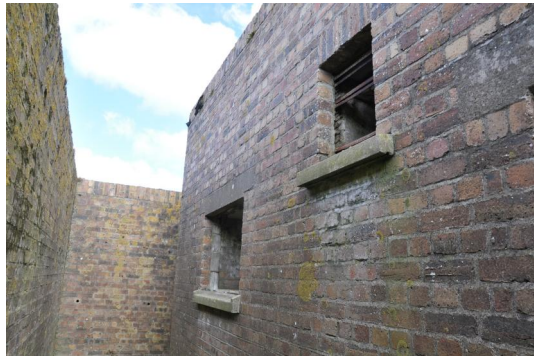
1.5.4 Gratings and grilles

Original iron grilles are corroded and mostly missing.

Replace grilles in galvanised steel

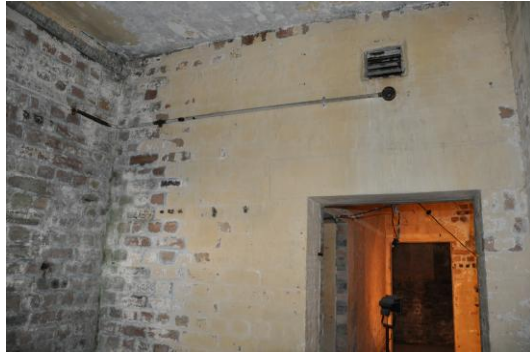
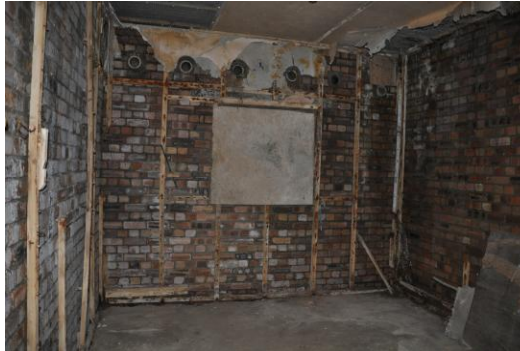
1.6.1 Internal Walls

Existing walls are in fair condition. Patches of algae etc in areas of ingress of water.

The former radio room has the remains of a 'Faraday Cage' with wire mesh on timber framing faced with board. This is in very poor condition.

Walls to be repainted using mineral paint to original colours.

Strip out and reinstate studwork, mesh and plasterboard to radio room.

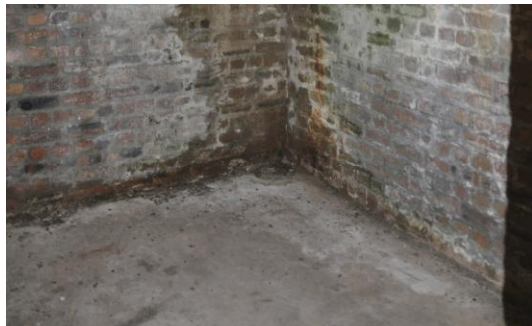
1.6.2 Floors

Existing concrete floors.

Clean out and paint floors

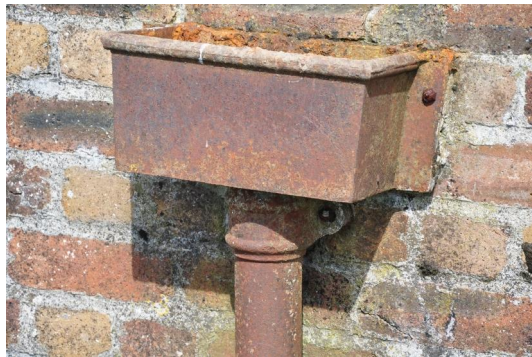
1.7.1 Rainwater Goods

Existing cast iron hopper heads and downpipes in rusted condition or missing.

Carefully remove and restore any existing rainwater goods.

Reform outlets through wall in lead.

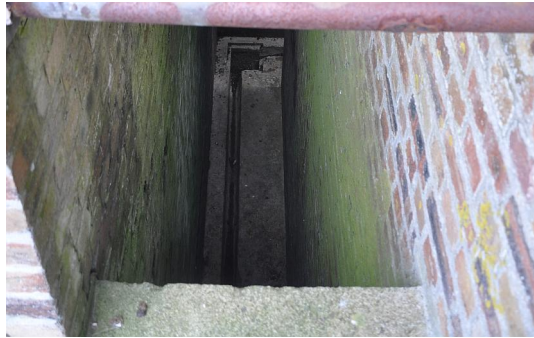
1.7.2 External Drainage

Existing roof drainage falls to channel in basement area with drain at NE corner.

Original covers are missing. Drain appears to be blocked.

Excavate and clear drain.

Form new soakaway.

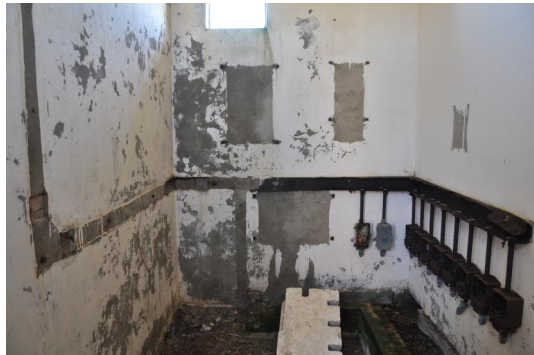
1.7.3 Existing electrical system

The existing electrical system has largely been stripped out. Some sections of conduit and original switchgear remain. In particular, some of the original runway lighting switchgear at first floor level.

Existing switchgear etc to be preserved and retained.

Install new electrical system in conduit with suitable period switches sockets and light fittings.

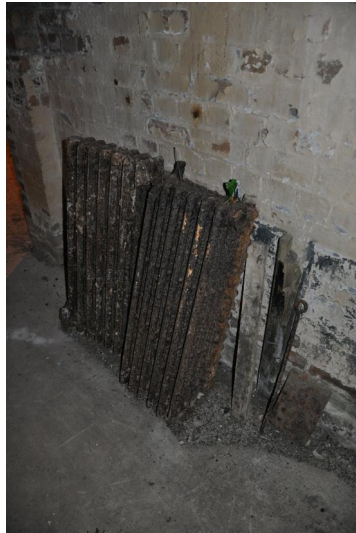
1.7.5 Heating

Remains of existing solid-fuel boiler in plant room.

Former 'hospital pattern' radiators generally no longer present. Those that remain are not in usable condition.

New electric radiators to traditional design as basic heating system.

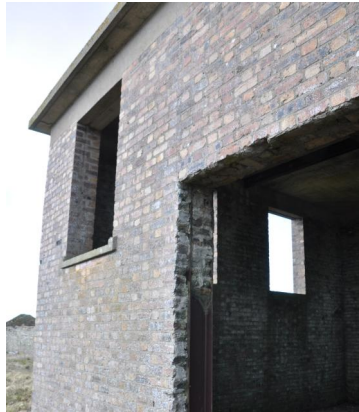
2.1.1 Beam to entrance door

Entrance has been enlarged by removing beam and areas of brickwork to each side. NO STRUCTURAL SUPPORT HAS BEEN PROVIDED TO THE WALL ABOVE.

URGENTLY Prop brickwork.

Reinstate brick piers to either side of doors and insitu reinforced concrete beam over.

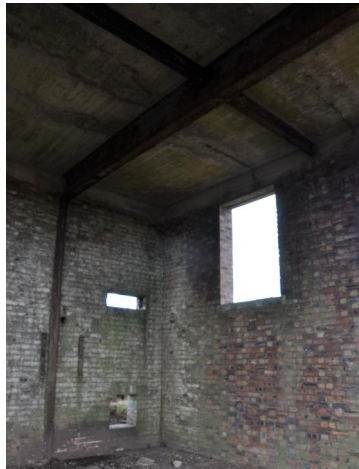
2.1.2 Steel Structure

Existing steel frame has surface rust.

Existing steelwork to be thoroughly inspected.

Clean off loose material, treat with rust-converting primer and paint system.

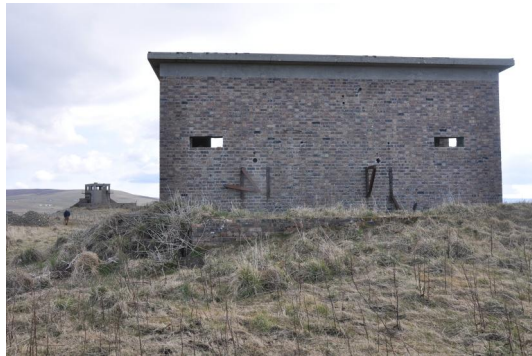
2.3.1 Brick Walls

Existing brickwork in good condition.

Allow for cleaning off and minor repointing.

Allow for building up redundant openings with brickwork.

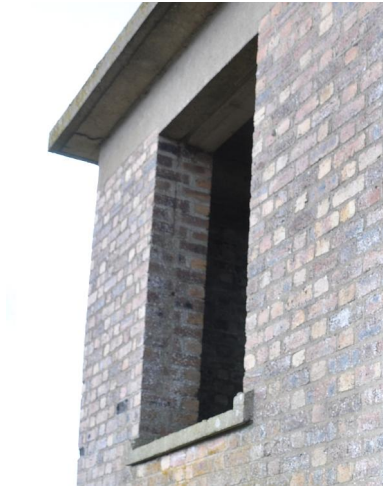
2.4.2 Windows

No existing windows

Install new steel windows.

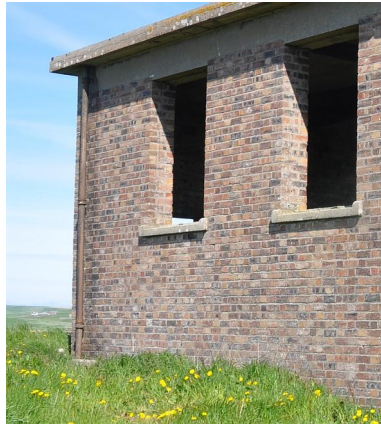
2.6.1 Rainwater

Existing cast iron downpipes.
In rusted condition and partly missing.

Take down, clean off and refurbish existing downpipes. Allow for 50% replacement.

Replace missing downpipe.

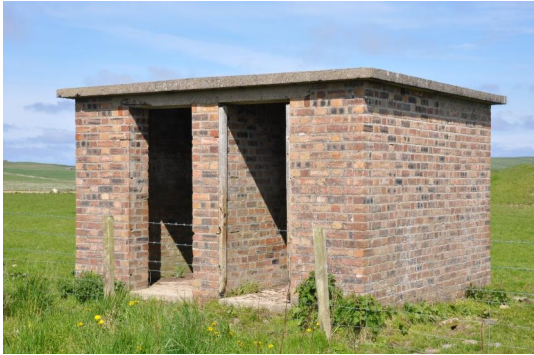
| Element | Condition | Recommendation | Priority |
|---|--|---|---|
| 3.2.1 Brick Walls | Existing brickwork in good condition. | Allow for cleaning off and minor repointing. Allow for building up redundant openings with brickwork. | |
